**Flood Control Project Maintenance
Levee Inspections**

Fall 2018 Levee Maintenance Deficiency Summary Report

Sacramento River Basin

RD0784	Overall LMA Rating	Total LMA Miles						
Reclamation District No. 0784 Plumas Lake	A	33.20						
Rated Item	Maintenance Deficiency				Enforcement		Design & System Obsolescence	
	M Miles	U Miles	M + 4U Miles	Threshold %	M Miles	U Miles	M Miles	U Miles
<i>Earthen Levee</i>								
Encroachments					2.70	0.49		
<i>Supplemental</i>								
2017 USACE Erosion Survey, DRAFT	0.01		0.01	0.03%				
DWR UCIP Field Study					0.02			
DWR UCIP LMA Responsibility								
<i>LMA Totals:</i>	0.01	0.00	0.01	0.03%	2.72	0.49	0.00	0.00
Unit No. 01 Yuba River LB	Overall Unit Rating	Total Unit Miles						
RD0784	A	2.21						
Rated Item	Maintenance Deficiency				Enforcement		Design & System Obsolescence	
	M Miles	U Miles	M + 4U Miles	Threshold %	M Miles	U Miles	M Miles	U Miles
<i>Earthen Levee</i>								
Encroachments					0.12	0.49		
<i>Supplemental</i>								
DWR UCIP Field Study					0.01			
<i>Unit Totals:</i>	0.00	0.00	0.00	0.00%	0.13	0.49	0.00	0.00

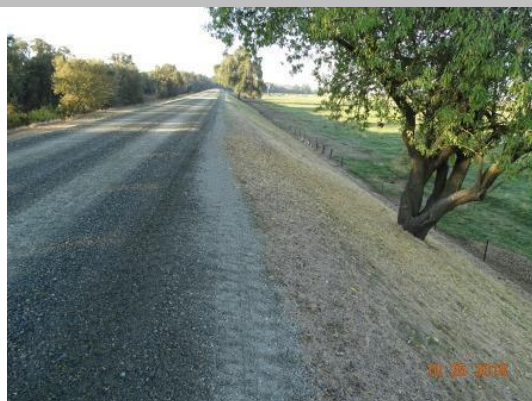
Photo 1 of 1 : FA_2018_RD0784_534_4_20181106_00008.jpg

LM Start	3.21	Rating **	A	Issue No.	4
LM End	4.68	Issue Type +	Ma	Location *	LS
Category	Earthen Levee			GPS Latitude/Longitude	
				Start	End
Item	Vegetation			38.974494 °	38.985440 °
				-121.532525 °	-121.510704 °
DWR ID	DWR_RD0784_03B_f_2018_4				
Comment Code					
V1 : Control annual grass and weeds on the levee slopes and easements.					
Inspector Comment					
The annual vegetation is well maintained, Fall 2018.

View looking downstream landside of the well maintained annual vegetation, Fall 2018.

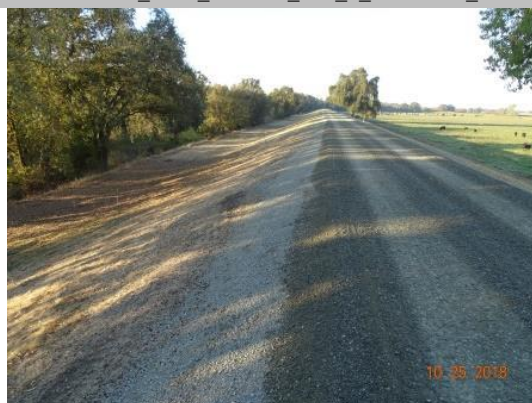
Photo 1 of 1 : FA_2018_RD0784_534_5_20181106_00007.jpg

LM Start	3.21	Rating **	A	Issue No.	5
LM End	4.68	Issue Type +	Ma	Location *	WS
Category	Earthen Levee			GPS Latitude/Longitude	
				Start	End
Item	Vegetation			38.974494 °	38.985440 °
				-121.532525 °	-121.510704 °
DWR ID	DWR_RD0784_03B_f_2018_5				
Comment Code					
V1 : Control annual grass and weeds on the levee slopes and easements.					
Inspector Comment					
The annual vegetation is well maintained, Fall 2018.

View looking downstream waterside of the well maintained annual Vegetation, Fall 2018.

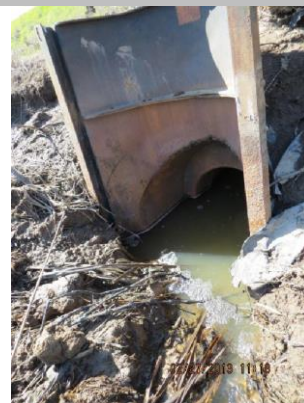
Photo 1 of 3 : UCIP_FA_2018_51711_16552.jpg

LM Start	0.12	Rating **	A/W	Issue No.	17
LM End	0.12	Issue Type +	Ma	Location *	
Category	Supplemental			GPS Latitude/Longitude	
				Start	End
Item	DWR UCIP LMA Responsibility			38.976147 °	38.976147 °
				-121.533019 °	-121.533019 °
DWR ID	18592				
Comment Code					
Inspector Comment					
FS_ID:51711					
DS_ID:18592					
EP_NO: N/A					
Repair Type: No Action Needed					
Crossing Status: Found					
UCIP Comments: 02/26/2013 Good candidate for video inspection. (W. Wylie - DWR UCIP)					
FIELD_STRUCT_DESC: 18-inch corrugated metal drainage pipe through the levee, 18 feet below the crown. Flap gate on the waterside (WS) end. Concrete U-shaped headwall on the WS end. Polyvinyl chloride weir inlet on landside (LS) toe. [Additional Reference(s): DWR Levee Log, 2005. USACE Sacramento O&M Manual 145, August 1955 (Station 25+28)].					
FS Date: 2/26/2013

inlet control structure on LS toe.

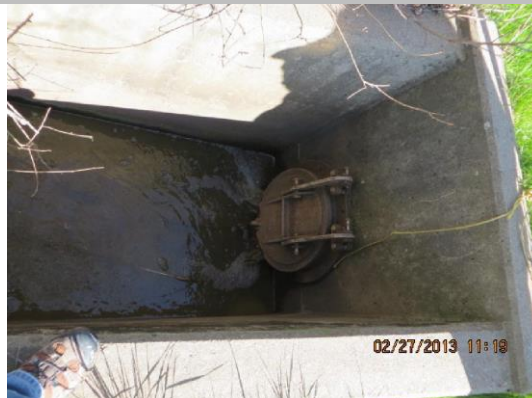
Photo 2 of 3 : UCIP_FA_2018_51711_16555.jpg

Concrete U-shaped outlet with flap gate on WS toe.

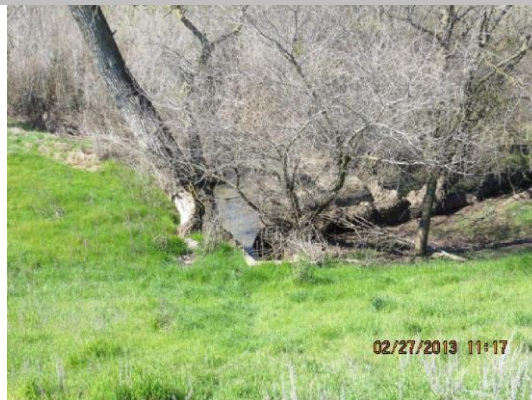
Photo 3 of 3 : UCIP_FA_2018_51711_16554.jpg

Concrete U-shaped outlet on WS toe.

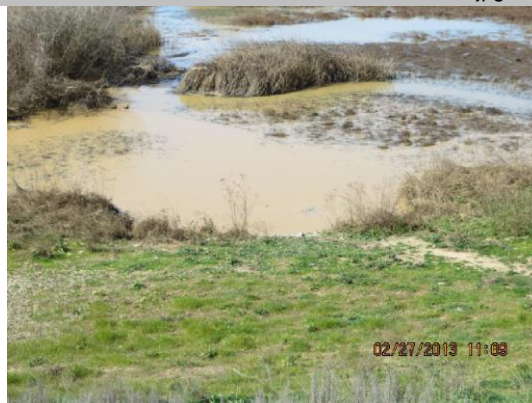
Photo 2 of 2 : UCIP_FA_2018_51710_54245.jpg

LM Start	0.84	Rating **	M	Issue No.	18	
LM End	0.84	Issue Type +	Ma	Location *		
Category	Supplemental			GPS Latitude/Longitude		
				Start		End
Item	DWR UCIP LMA Responsibility			38.986432 °		38.986432 °
				-121.534983 °		-121.534983 °
DWR ID	18591					
Comment Code						
Inspector Comment						
FS_ID:51710 DS_ID:18591 EP_NO: N/A Repair Type: Non-Urgent Crossing Status: Found UCIP Comments: 02/26/2013 No handle or access to slide gate on LS toe. (W. Wylie - DWR UCIP) FIELD_STRUCT_DESC: 30-inch corrugated metal drainage pipe through the levee, 23.7 feet below the crown. Flap gate on the waterside (WS) end. Slide gate inside a concrete drop inlet on the landside (LS). [Additional Reference(s): DWR Levee Log, 2005. USACE Sacramento O&M Manual 145, August 1955 (Station 63+00)]. FS Date: 9/11/2015 9:05:00 AM

Outlet with riprap on WS toe.

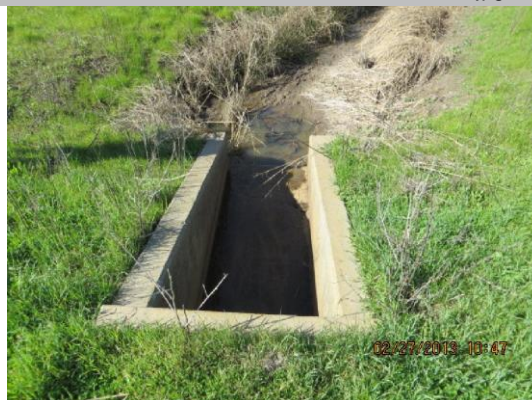
Photo 1 of 3 : UCIP_FA_2018_51719_54247.jpg

LM Start	1.86	Rating **	M	Issue No.	20
LM End	1.86	Issue Type +	Ma	Location *	
Category	Supplemental			GPS Latitude/Longitude	
				Start	End
Item	DWR UCIP LMA Responsibility			39.000975 °	39.000975 °
				-121.537779 °	-121.537779 °
DWR ID	18588				
Comment Code					
Inspector Comment					
FS_ID:51719 DS_ID:18588 EP_NO: N/A Repair Type: Non-Urgent Crossing Status: Found UCIP Comments: 09/11/2015 Inlet burried. Good candidate for video inspection as pipe is corroded. (G. Wylie - FPIIB) FIELD_STRUCT_DESC: 18-inch corrugated metal drainage pipe through the levee, 14.5 feet below the crown. Flap gate on the waterside (WS) end. Concrete U-shaped headwall on the WS. [Additional Reference(s): DWR Levee Log, 2005. USACE Sacramento O&M Manual 145, August 1955 (Station 116+78)]. FS Date: 9/11/2015 9:36:00 AM

Concrete U-shaped outlet and flap-gate on WS toe.

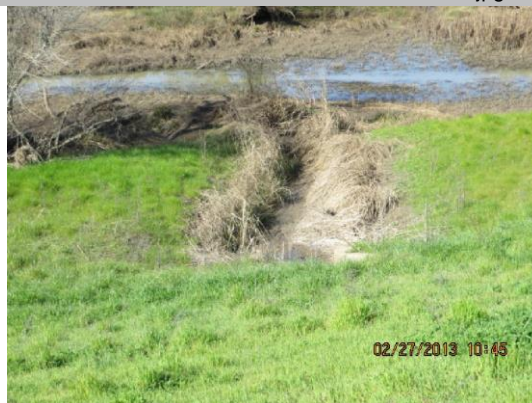
Photo 3 of 3 : UCIP_FA_2018_51719_54249.jpg

Drainage outlet on WS toe.

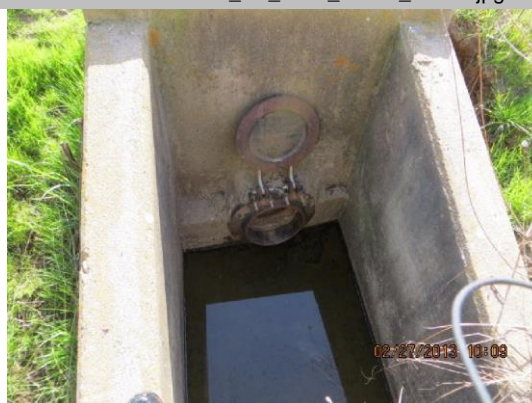
Photo 1 of 3 : UCIP_FA_2018_51714_54259.jpg

Comment Code						
Inspector Comment						
FS_ID:51714						
DS_ID:18596						
EP_NO: N/A						
Repair Type: Non-Urgent						
Crossing Status: Found						
UCIP Comments: 02/27/2013 Pipe has been sliplined with PVC, but the liner appears to be eroding at outlet and may be disjointed internal to the levee. See pic. Good candidate for video inspection. (W. Wylie - DWR UCIP)						
FIELD_STRUCT_DESC: 12-inch corrugated metal drainage pipe through the levee, 12 feet below the crown. Flap gate and concrete U-shaped headwall on the waterside (WS). Polyvinyl chloride weir on inlet at the landside (LS) toe. [Additional Reference(s): DWR Levee Log, 2005. USACE Sacramento O&M Manual 145, August 1955 (Station 44+96)].						
FS Date: 9/11/2015 9:26:00 AM

Concrete U-shaped headwall and flap gate on WS toe.

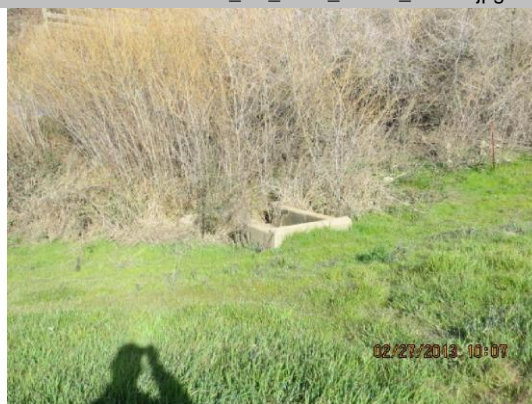
Photo 3 of 3 : UCIP_FA_2018_51714_54261.jpg

Concrete U-shaped headwall on WS toe.

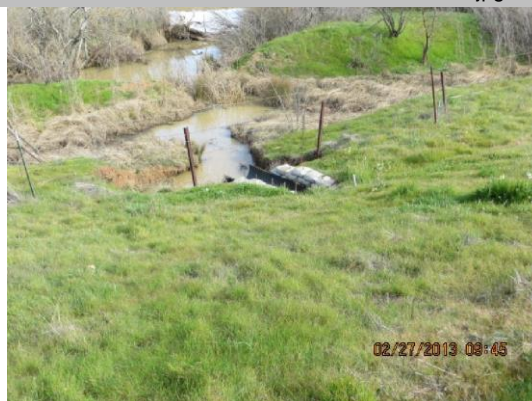
Photo 3 of 3 : UCIP_FA_2018_51713_16592.jpg

LM Start	3.79	Rating **	A/W	Issue No.	25 (cont)	
LM End	3.79	Issue Type +	Ma	Location *		
Category	Supplemental			GPS Latitude/Longitude		
				Start	End	
Item	DWR UCIP LMA Responsibility			39.019222 °	39.019222 °	
				-121.516414 °	-121.516414 °	
DWR ID	18594					
Comment Code						
Inspector Comment						
FS_ID:51713 DS_ID:18594 EP_NO: N/A Repair Type: No Action Needed Crossing Status: Found UCIP Comments: FIELD_STRUCT_DESC: 18-inch corrugated metal drainage pipe through the levee, 8.8 feet below the crown. Flap gate and headwall on the waterside (WS) end. [Additional Reference(s): DWR Levee Log, 2005. USACE Sacramento O&M Manual 145, August 1955 (Station 83+39)]. FS Date: 2/27/2013

Concrete outlet on WS toe.

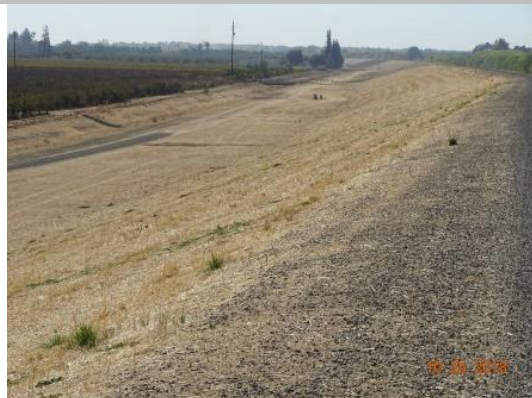
Photo 1 of 1 : FA_2018_RD0784_530_1_20181106_00002.jpg

LM Start	2.48	Rating **	A	Issue No.	1
LM End	5.69	Issue Type +	Ma	Location *	LS
Category	Earthen Levee			GPS Latitude/Longitude	
				Start	End
Item	Vegetation			39.054982 °	39.010390 °
				-121.592375 °	-121.579600 °
DWR ID	DWR_RD0784_09_f_2018_1				
Comment Code					
V1 : Control annual grass and weeds on the levee slopes and easements.					
Inspector Comment					
The annual vegetation is well maintained, Fall 2018.

View looking downstream landside of the well maintained annual Vegetation, Fall 2018.

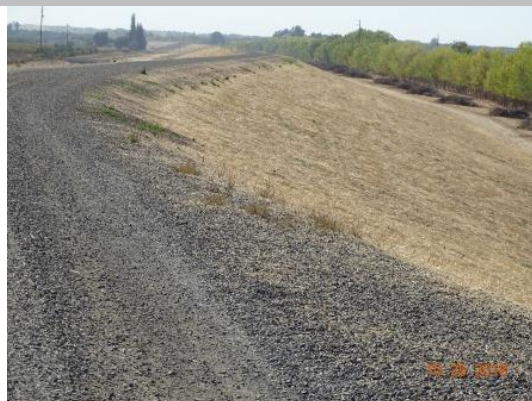
Photo 1 of 1 : FA_2018_RD0784_530_2_20181106_00001.jpg

LM Start	2.48	Rating **	A	Issue No.	2
LM End	5.69	Issue Type +	Ma	Location *	WS
Category	Earthen Levee			GPS Latitude/Longitude	
				Start	End
Item	Vegetation			39.054982 °	39.010390 °
				-121.592375 °	-121.579600 °
DWR ID	DWR_RD0784_09_f_2018_2				
Comment Code					
V1 : Control annual grass and weeds on the levee slopes and easements.					
Inspector Comment					
The annual vegetation is well maintained, Fall 2018.

View looking downstream waterside of the well maintained annual Vegetation, Fall 2018.
